3rd Conference on Sustainability in Civil Engineering (CSCE'21)
Department of Civil Engineering
Capital University of Science and Technology, Islamabad Pakistan

MODERN REPAIRING TECHNIQUES OF RC BUILDINGS DAMAGED DUE TO EARTHQUAKE DISASTER –A REVIEW

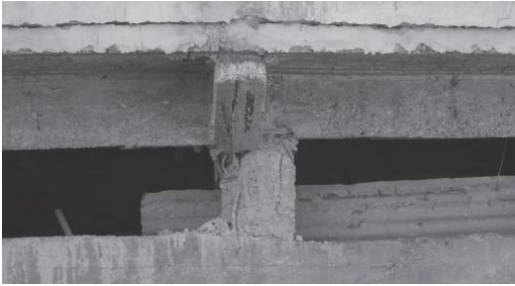
Figure 3: Shear failure in RC short column [1]

Columns are the compressive members of RC structure. RC columns must have sufficient ductility and rigidity in earthquake resistance design framework. Under seismic load, columns cannot fulfil the displacement demand hence expected performance cannot be achieved. The phenomenon mostly occurs in case of short columns where stiffness is quite high due to shorter in length than other floor columns [12]. The seismic motion cause lateral load effect whereas short columns try to compensate it by stiffness. Hence short columns do not show the desired ductile behavior. In this scenario, to increase ductility, shear reinforcement is increased [13]. Figure 3 shows the short column shear failure in RC building structure [1]. The failure of beam and column joint can be happened due to insufficient length of development (see figure 4). The development of full strength happens when length of embedment is sufficient.

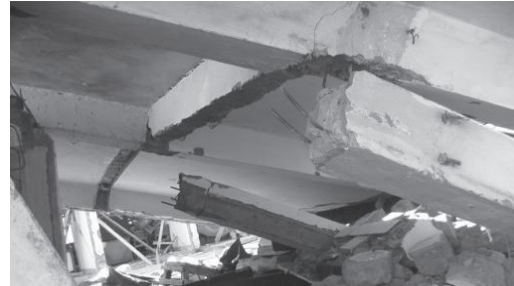
Figure 4: Anchorage failure [1]
