# ASSESSMENT OF BARS LAYOUT ON THE STRENGTH OF EXISTING RC HALF-JOINT STRUCTURES USING THE PLASTIC REDISTRIBUTION METHOD

Eirini Balantina<sup>a</sup>, Shunde Qin<sup>b</sup> and Furqan Qamar<sup>c</sup>

**2<sup>nd</sup> Conference on Sustainability in Civil Engineering (CSCE'20)**

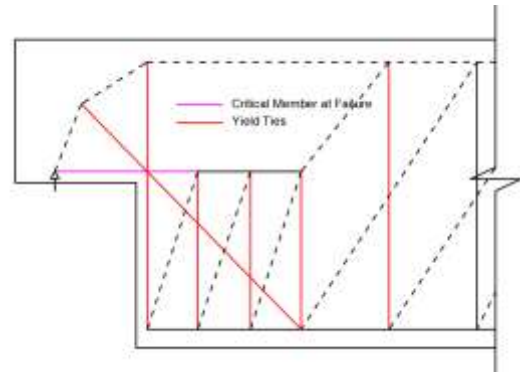
(a) NS-REF

The highest predicted failure load of 431.9kN was obtained using the PRM for the reference specimen differed with the empirical data by 6.8% (Table 1). The failure of the half joint occurred when the horizontal and inclined reinforcement reached their yield resistance and caused half joint failure. The same failure mode was also observed during the empirical testing; the half-joint failure observed because of rupture of the U-bar and diagonal reinforcement at the re-entrant corner location. By reducing shear reinforcement amount, the capacity of the beam was reduced by 10.9 %, resulting in 385 kN failure load in model, which differed to the failure load from the experimental work carried out by Desnerck et al (358 kN failure load) by 8%. However, the PRM failure was occurred in the horizontal reinforcement (U-bar) and not due to a full-depth shear failure as recorded during the experiments. This may be explained due to the assumption that was made that the horizontal reinforcement was fully anchored, preventing from developing cracking in the full depth area and resulting in a theoretical failure at the corner of re-entrant.

Figure 3: Comparison of Failure Mode (Experimental vs SRM)

The resistance of the half joints without U-bar and diagonal reinforcement, calculated with the PRM, was slightly less as compared to the experimental results obtained by Desnerck et al. In contrast, for both the reference and with the decreased shear bars samples, the resistance of the half joint was slightly increased in comparison with the experimental work. The failure load and failure mode for all specimens for PRM and experimental work are shown in Table 1 and Figure 3.

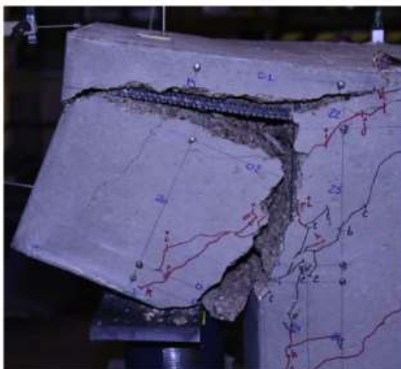
(c) No U Bar (NS-NU)

It is also worth to note that all the partial factors were set to 1.0 for the plastic redistribution assessment. The absence of the horizontal U- bars, reduced the beam capacity, resulting in 237.6 kN failure load and reducing the half joint resistance by 45% compared to the reference specimen. The predicted failure load and empirical value differ by 12%. The highest decrement had been observed with elimination of diagonal reinforcement, resulting in 227.6 kN predicted failure load which differs to the empirical load by 7 %. The resistance of the half joint without the diagonal bars was decreased by 47% in comparison with the capacity of the reference model calculating with the PRM. The failure of the NS-ND and NS-NU specimens occurred because of diagonal and horizontal reinforcement in the corner of re-entrant, respectively, and it matches the failure mode observed during the experimental works.
