## **DAMAGE ASSESSMENT OF HISTORICAL BUILDINGS: A CASE STUDY OF HISTORIC SHRINE OF MULTAN**

**Keywords-** Historical structures, Masonry, Damage assessment, visual inspection.

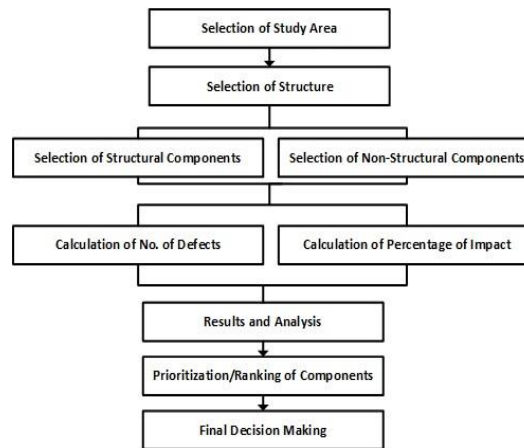
Figure 1. Framework for Research

A comprehensive methodology has been formulated in the Fig.1 which is formulated based on existing research literature[5, 6] related to historical building damage assessments.

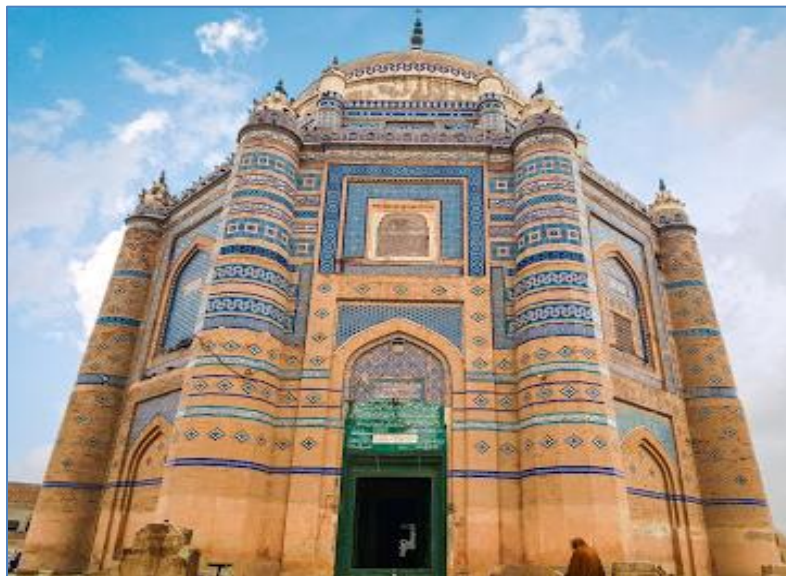
Figure 3: Mausoleum of Shah Ali Akbar-Historical shrine of Multan, Pakistan.

Although this shrine is a smaller version of Shah Rukn-e-Alam's shrine, it is richer in faience embellishment and tile inscriptions as shown in Fig.3. It has an octagonal plan, three stories tall and tapering angle buttresses crowned by turrets similar to the Shrine of Shah Rukn-e--Alam. The entire structure is almost 85 feet in height with an external finish of glazed geometric patterned tiles. These are still intact and reflect the development of the Multani style of the blue tile set in brick masonry. The walls have horizontal wooden beams laid within the masonry courses and are decorated with brick designs and tile work. The openings have wooden grills, some of which have been damaged in the second storey and are now blocked by brick masonry. There are arches one above the other with openings set with wooden fretwork screens in the upper two levels. There is a staircase created within the thickness of the wall just adjacent to the entrance that provides access to the roof of the second storey through one of the windows. The floor of the entrance is finished in large square tiles with a glazed design whereas the rest of the floor inside the shrine is finished with bricks on the edge. The external six feet high platform, upon which the structure rests, has recently been plastered with cement. The front solid wood door is painted green. The interior is richly embellished with original specimens of *naqashi* in *floral* and *geometric* patterns in horizontal and vertical panels, following the structural elements and recesses in the walls. Some of the rarest examples are arabesque designs in relief which can be seen on the interior walls. However, all these specimens currently are in a precarious state. The interior of the monument has been considerably damaged by the smoke of the candles and mustard oil lamps that are lit by the pilgrims visiting the shrine particularly the *naqashi work* and lime plaster. Little of the original decoration survives in presentable condition. Externally, decay has set in at several places including walls, corner buttresses, grills, and panels of inscriptions due to rising dampness and weathering.

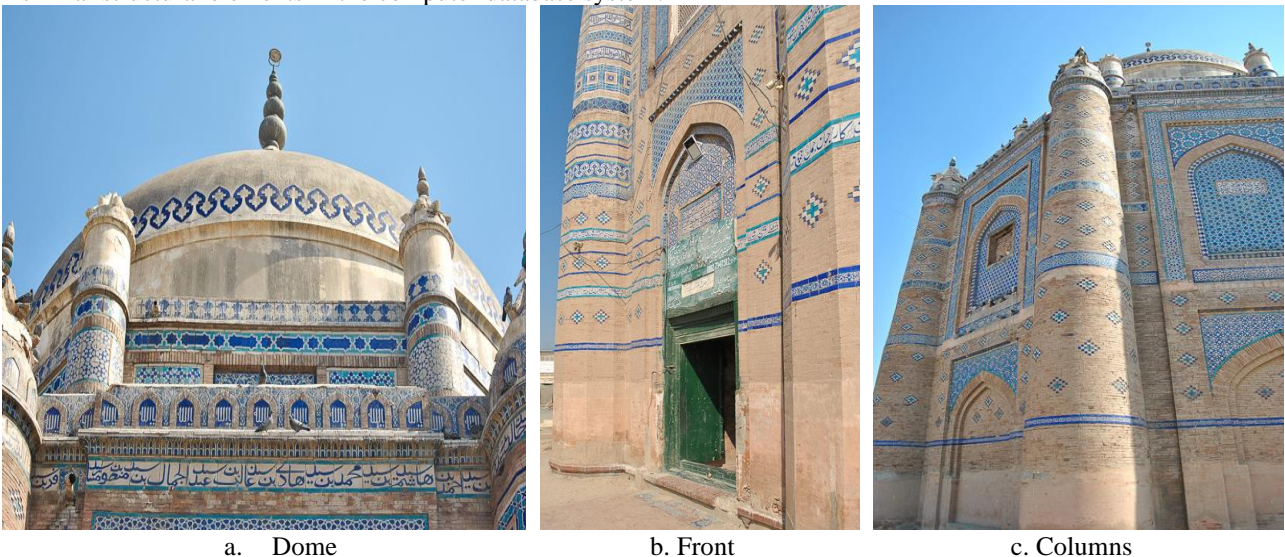
Figure 4: Example of Analyzing Existing Structure Component Wise

The computer database program analyzes the inspection data in the proposed system. Therefore, it is important to identify each structural element of the inspected building as well as a general method in computerized data properly using Excel analyzing the existing structure component-wise [11]. Also, checklist and questionnaire forms should be used and organize properly for inspection in a computer database. It is a hard job to examine the structure as well as to make interrelation of all similar structural elements in the computer database system.

During the inspection, each structural element is therefore inspected to characterize its real geometry in the form of the datasheet. The structure is divided into components before inspection of the existing structure by which each structural feature can be defined by its actual geometry shapes such as circular, semi-circular, curvilinear, or irregular and its location i.e., orthogonal, or non-orthogonal or octagonal. It is not necessary to be precise in drawing applications while giving the axes and drawing every axis through the center of the component. The focus is to straightforwardly identify all structural components and using the minimum axis lines as much as possible. The way of giving an axial method to historic buildings as an example is displayed in Fig.3.
