RETROFITTING OF CONFINED MASONRY STRUCTURE WITH FIBER REINFORCED POLYMER (FRP)

Keywords: confined Masonry, retrofitting, seismic

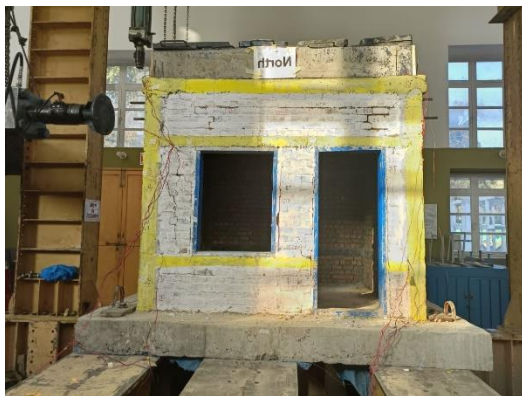
a)

Figure 2: CM results, a. Failure of confined vertical column b. Envelope curve

A cyclic horizontal load was performed on the model. The damage scheme is shown in Figure 2. A. The primary type of failure observed was a step crack that traversed mortar joints and a diagonal shear crack in the confined vertical column at the joint where the slab corner meets. The experiment was halted when reaching a maximum displacement of 19 millimeters, resulting in moderate damage. Figure 2. b illustrates the envelope curve of the CM structure. The structure reached its high lateral load-resisting capacity (40.50 KN) at 18mm displacement, after which strength degradation started.

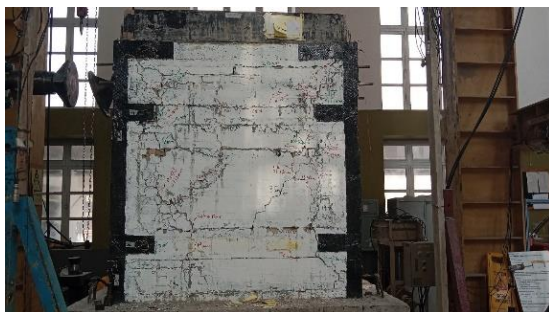
a)

Figure 3: Retrofitted CM results, a. Failure of retrofitted confined tie column b. Envelope curve

Similar to the CM structure, a shear crack at an angle appeared in the tie column near the corner joint of the slab, which was wide enough to be visible during testing, and the FRP was ruptured at that point, as shown in Figure 3. a. The test was then stopped. Figure 3. b shows hysteresis loops of retrofitted confined masonry structures. The structure's highest resistance was 57KN, reached at a displacement of 28mm, following which there was a gradual decrease in strength.
