# ENHANCING STRUCTURAL INTEGRITY AND RESILIENCE: A SYSTEMATIC APPROACH FOR RETROFITTING DESIGN OF A TWO-STORY HOSPITAL BUILDING IN KARACHI

**Abstract-** This paper presents a case study on the structural assessment and retrofitting design of a two-story hospital building in Karachi, Pakistan, constructed in 1992. To overcome this, a systematic approach was adopted, involving site visits, data gathering, the creation of as-built drawings, and detailed analysis and design using ETABS software. The assessment revealed vulnerabilities in the existing structure, particularly in the columns, which necessitated retrofitting measures. The retrofitting design included the incorporation of shear walls and the increase in column and beam sizes to enhance the building's seismic resilience. The successful completion of this project underscores the importance of a systematic approach in ensuring the structural integrity and resilience of existing buildings, especially in earthquake-prone regions. By prioritizing the preservation of human life and the enhancement of building safety, this study contributes to a more resilient built environment.

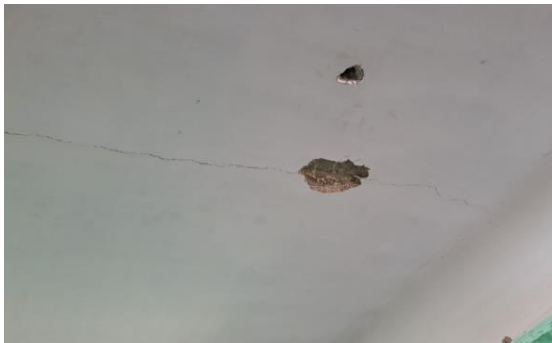
a)

Figure 1: Observed structural cracks, a. Existing roof slab, b. Existing concrete beam.

To assess the building's integrity, a team of senior structural engineers and architects carried out a visual inspection of the existing building. A conditional survey by visual inspection was based on ACI 201.1R-08 which serves as a Guide for Conducting a Visual Inspection of Concrete in Service and ACI 364.1R-07 which is used for the guide of evaluation of concrete structures before rehabilitation [5, 6]. In Figure 1, on-site investigations and measurements of visible cracks have been found at the slab (Figure 1a) and existing beam (Figure 1b), the cracks observed are due to a combination of factors, including the seismic activity and the overloading. [9].
