Retrofitting of Damaged Gravity Designed Reinforced Concrete Exterior Connection using Energy Dissipating Haunch

Babar Ilyas¹, Naveed Ahmad², Mian Asfahan Ali Gul³ and Arif Ullah⁴

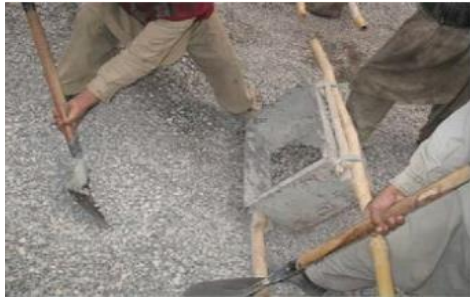
Figure Error! No text of specified style in document.-1: Manual batching and mixing

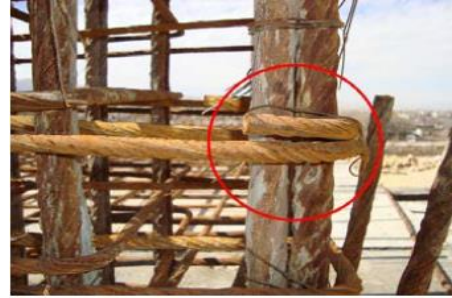
Figure Error! No text of specified style in document.-2: Bent Reinforcement and Non-
Seismic Hooks

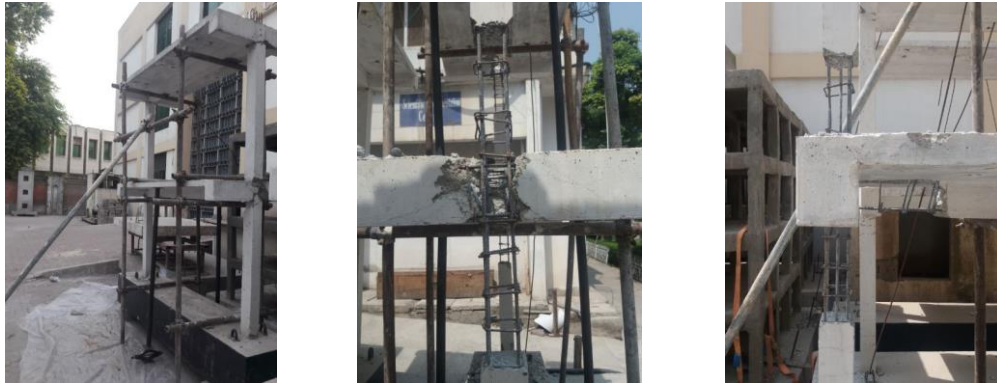
Figure 2-1: (a) Damaged Frame, (b) Damaged concrete removed from joints, (c) Joint after concrete removal

The retrofitting process of damaged RC portal frame consists of four steps i.e. removal of concrete, model repositioning, concrete replacement and haunch installation. Initially the model was supported by applying jacks to both the floors and lateral support was provided to avoid the collapse of model during retrofitting process as shown in Figure 2-1(a). The damaged concrete from the joint region, columns and adjacent beams was removed up-to 2 times the depth of the joining members as shown in Figure 2-1(b) and 2-1(c). Repositioning was performed with the help of belts to remove the out of plane tilt from the model. Joint concrete was replaced with rich concrete (34.5 MPa) in order to increase the joint's shear capacity and to provide better anchorage to the haunch element by joining members Figure 2-1(d) and 2-1(e).

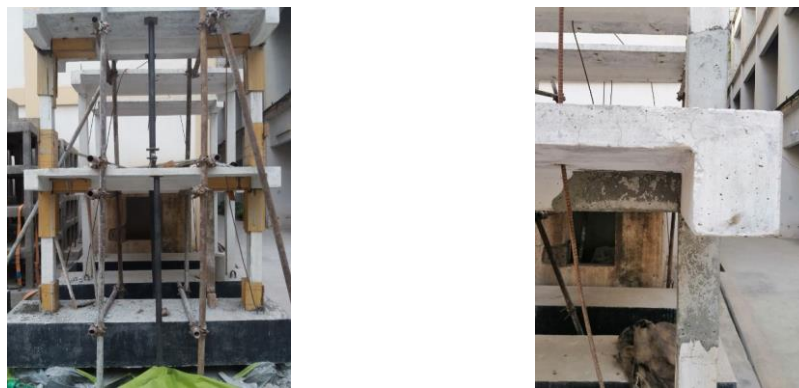
(d) Formwork for concreting, **(e)** Joint after replacing damaged concrete

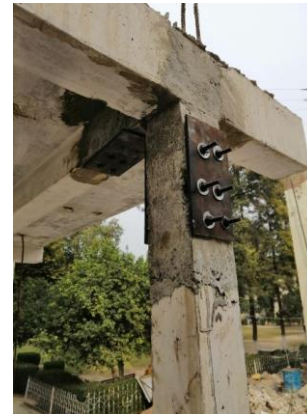
The type of anchorage used in this research is through anchorage. It consists of 6 bolts passing through steel plates at both sides of the column and beam Figure 2-4.

Figure 2-4: Through Anchorage in beam

and columns

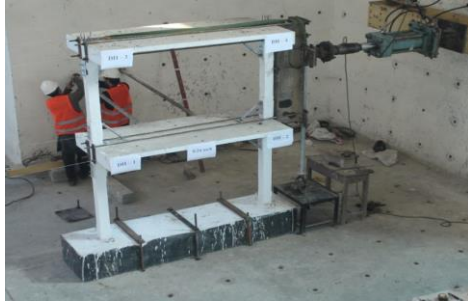
Quasi static lateral cyclic load was applied to the test model with the help of displacement-controlled hydraulic actuator. The actuator consists of a ram and load cell having capacity of 50 tons and having ± 6 in (150 mm) displacement capacity of the shaft. The hydraulic actuator is connected to the vertical distribution beam at 1/3rd span from the top end, to apply lateral loads simulating triangular lateral force distribution. The test setup of the retrofitted specimen is shown in **Figure 2-5**.

Figure 2-5: Test Setup
