## **Repair and retrofit of beam-column joints of a damaged two story RC-frame**

A 1/3<sup>rd</sup> reduced scale two story reinforced concrete frame tested on shake table was repaired and retrofitted using steel haunches, to check the efficiency of haunch retrofitting in restoring seismic capacity. Repairing was done by removal of damaged concrete from the joints and replacement with rich concrete. Haunches were installed at each joint to change the hierarchy of strength from brittle shear damage in joints to ductile flexure damage in the beam. Testing was performed using quasi-static cyclic loading setup. From the comparison of the tests it was observed that the repaired and retrofitted frame showed a ductile failure mechanism of beam flexure cracking as compared to joint shear cracking in as-built frame. Also a substantial increase in the seismic response parameters of the retrofitted frame was noted showing the effectiveness of the repair and haunch retrofitting technique.

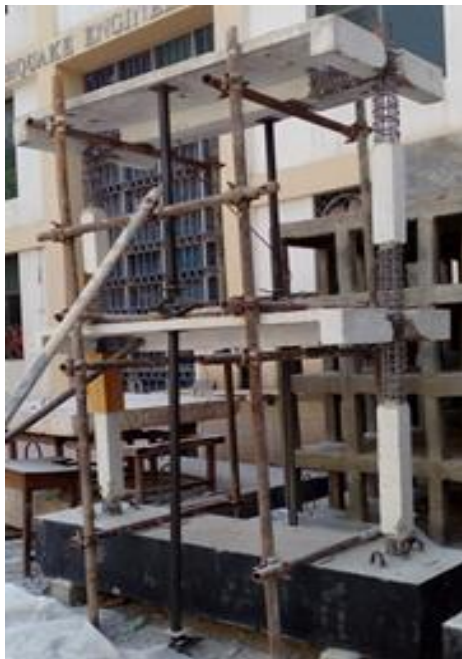
Figure 2: Removal of damaged concrete. Figure 3: Replacement with rich concrete.

The damaged frame was repaired by firstly repositioning the frame from the induced tilting due to testing, then the removal (Figure 2) of damaged concrete from joint and the adjacent beams and column region, which was replaced (Figure 3) with rich concrete of 5000psi of compressive strength. Concrete of higher strength was used in the joints to increase its shear strength, and in the adjacent parts of the beams and

columns for better anchorage of the haunches to the beam and column.

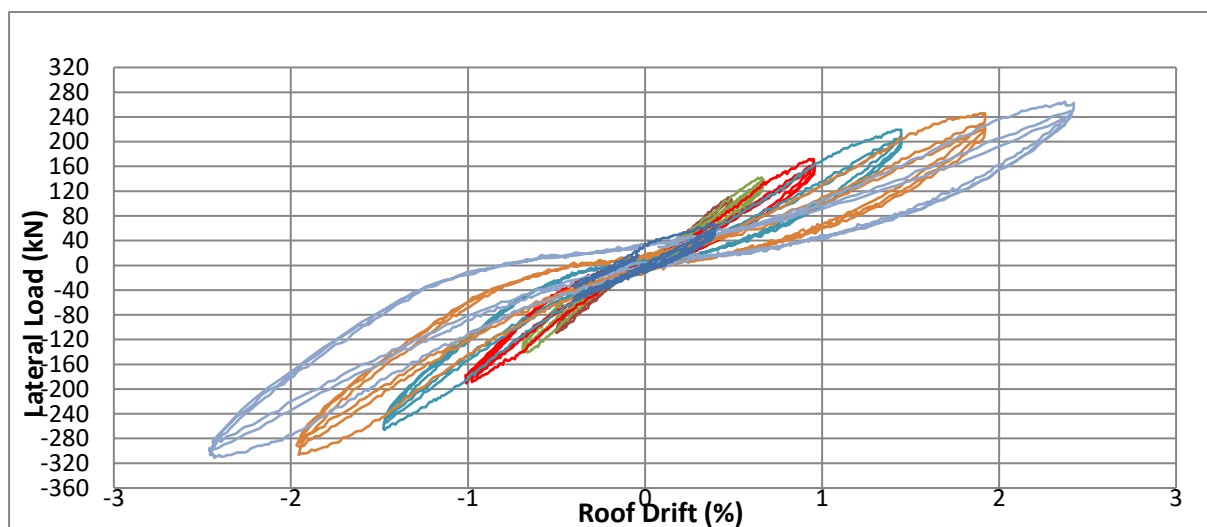
Figure 5: Force-displacement hysteretic response of prototype of retrofitted test frame.

By starting with the application of 0.4% of roof drift and increasing to 2.5% as per ACI ITG-5.1-07 protocol, the damage started with hair line cracking in the beam at the end of haunch plates that widened significantly in the subsequent drifts up-to 2.5%. Also some hair line shear cracking in the joints and shear cracking in the columns of ground story at the end of haunch plates was observed during the application of the last drift cycle, which can be attributed to the detachment of the haunches through concrete pry-out that further weakens the substrate member. Also some pinching behavior in the load-deformation response (figure 5) of the frame was observed that can be attributed to the opening and closing of already existing cracks, which can be controlled/minimized by injecting epoxy.

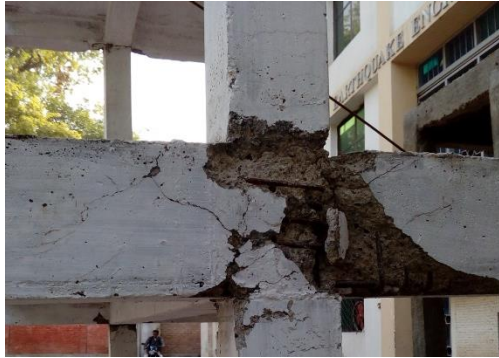
In case of the as-built frame tested by Rizwan et al (2018) through a shaking table, that was built using low strength concrete, had lower load resistance and higher deformation under same loading conditions. This frame has also lower lateral load capacity due to early joint shear failure (Figure 6) due to the use of low strength concrete. The frame when then repaired using higher strength concrete and with haunches installed showed much higher stiffness and lateral load capacity. This can be attributed to the higher joint shear strength due to the use of rich concrete and also due to the shear transfer mechanism produced by the haunches installed at beam-column joints, from joint to the beam. That resulted into flexure plastic hinge (Figure 7) formation in beam as opposed to joint shear damage mechanism in as-built frame.

Figure 6: Damage in joint of as-built frame      Figure 7: Flexure cracking in beam of retrofitted frame.
